## Landlok<sup>®</sup> TRM 450 Permanently Reinforces Vegetation in Arizona Channels

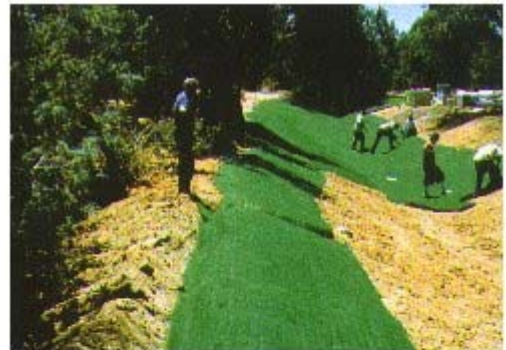
June, 1995 Installation of Landlok TRM 450

Revegetation Services, an Arizona based erosion control contractor, began construction following design completion and Town approval. After subgrade preparation, the TRM was installed, seeded with a mix including: Indian blanket, California poppy, burnet clover, crested wheatgrass, Boer lovegrass, Madrid sweetclover, and green spangletop, then soil-filled to a depth of 3/4" (1.9 cm). The soil cover was specified to accelerate germination and seedling development, maximize root entanglement with the matrix, add ballast to the installation, and provide additional UV protection prior to vegetative development.

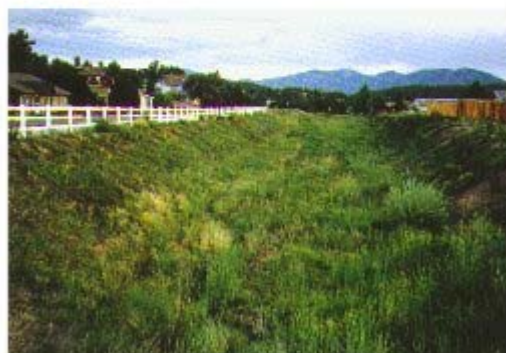
Vegetative establishment after one year.

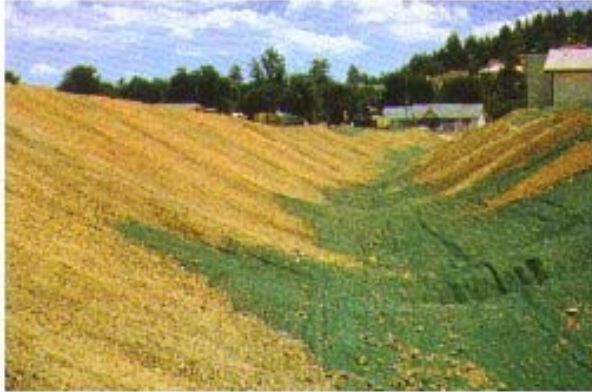
The TRM was soil-filled to maximize performance.

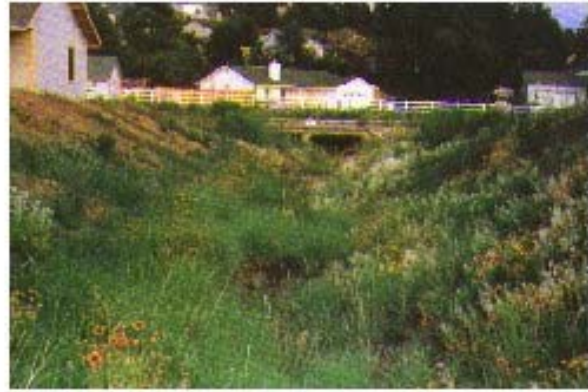
Aesthetically pleasing channel provides permanent protection.

Nearly two years later, vegetation is flourishing in this semi-arid section of Arizona, and the channels are performing well.
